NOTICE OF COMMENCEMENT & PUBLIC INFORMATION CENTRE #1 TALBOTVILLE WWTP CLASS EA

NOTICE OF STUDY COMPLETION TALBOTVILLE WWTP CLASS EA

Appendix 6.1
Archaeological Assessment Report

Original Report on Archaeological Assessment (Stages 1 & 2) 10065 Gore Road, Talbotville, Lot 40, Concession SENTBR

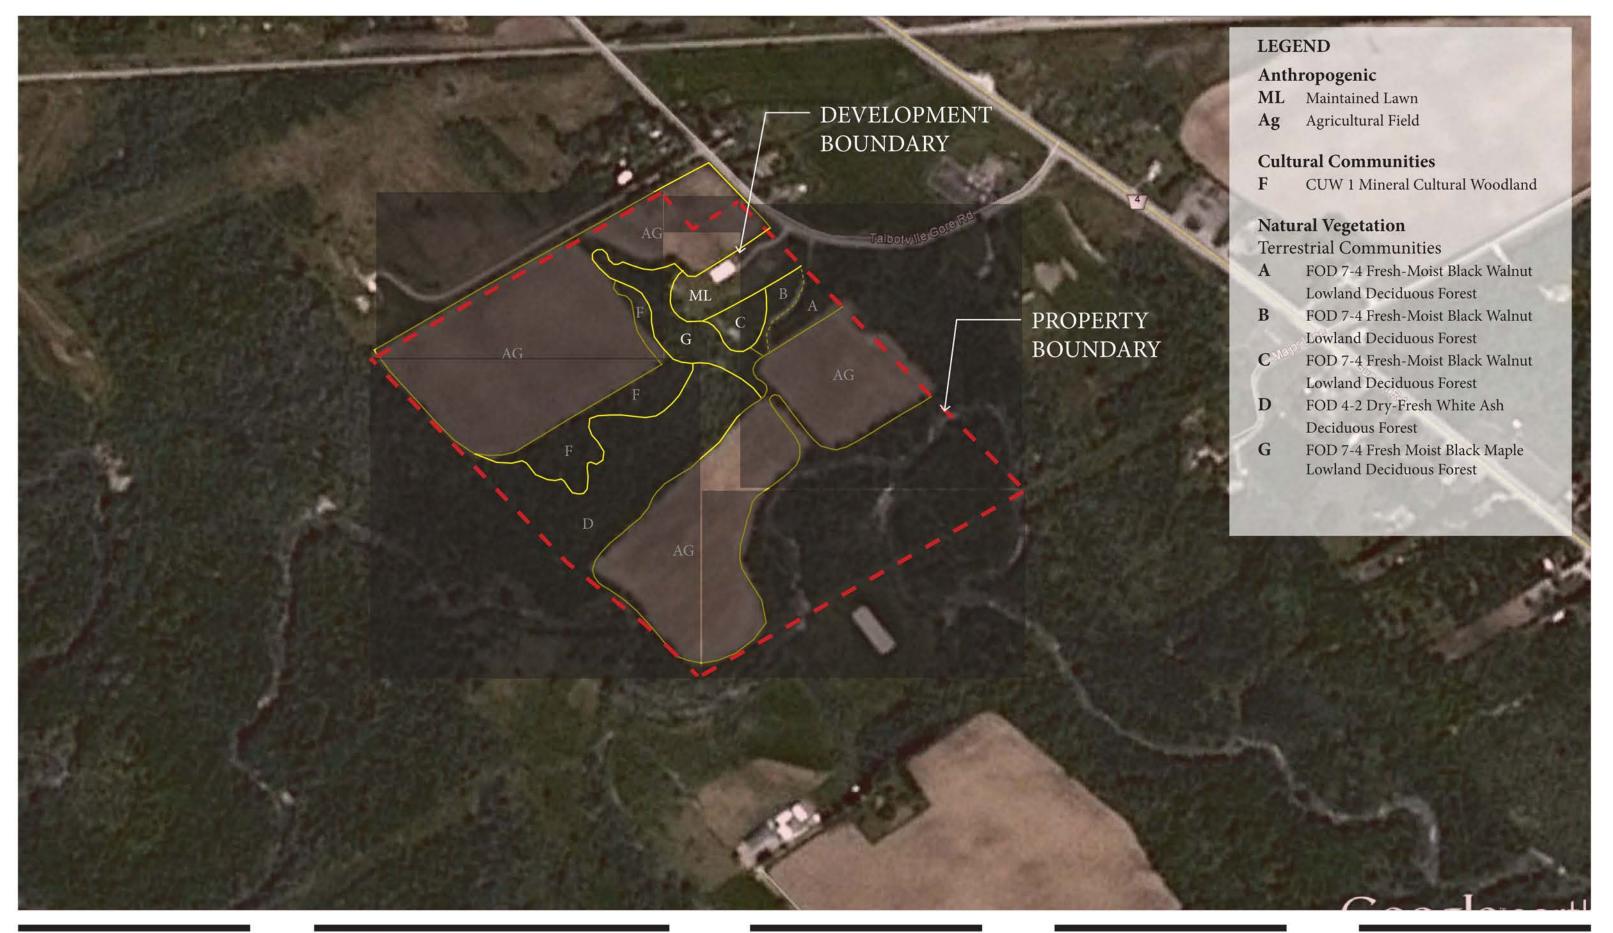
FIGURE 3

The subject lands are adjacent to Dodd's Creek, which is located to the south. On the site itself there is an incised, first-order intermittent stream that flows north to south through a portion of the site, connecting to Dodd's Creek. Vegetated slopes of about 25-50% are found between the upland portion of the site that comprises the development parcel (the subject lands) and the lower portion within the Dodd's Creek floodplain (Tab A: Figure 3).

Seasonal groundwater seepage at isolated locations along the toe of slope was observed in the south-east corner of Community D (Figure 3) during the 2011 Fall season and the 2012 Spring season. This seepage zone was dry at all other periods observed, indicating that these variations represent base flow contribution from a seasonally fluctuating groundwater table.
